BROAD CREEK DAM

NDI NO. MD 00017

PHASE I INSPECTION REPORT

NATIONAL DAM INSPECTION PROGRAM

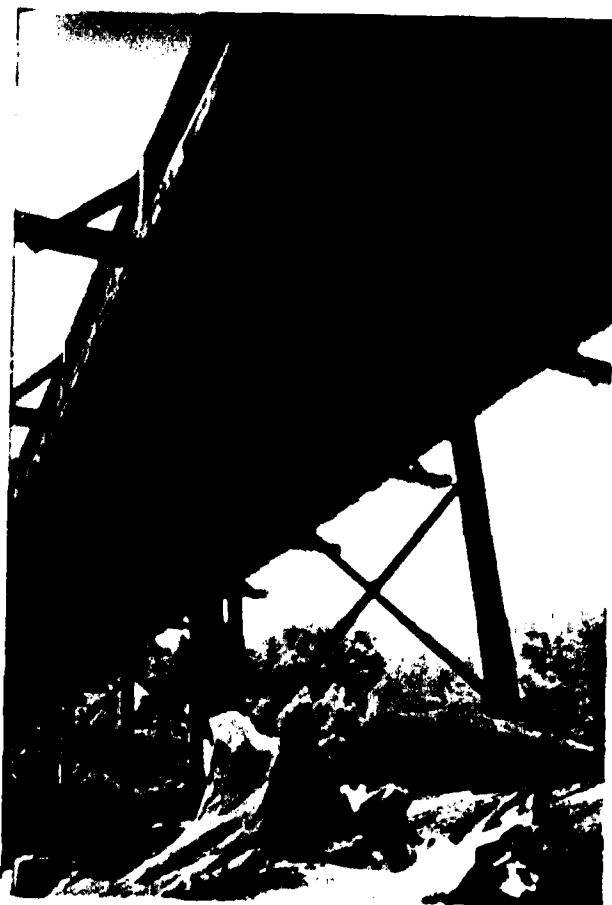
BRIDGE OVER
SPILLWAY

VISUAL EXAMINATION OF	OBSERVATIONS AND REMARKS/RECOMMENDATIONS
CONCRETE WEIR	See Concrete/Masonry Dams
APPROACH CHANNEL	N/A
DISCHARGE CHANNEL	Natural stream channel
BRIDGE AND PIERS	Bridge and piers over spillway in good condition. Bridge appears not to have been constructed according to any accepted design standard.

c. Appurtenant Structures. The leak in the drain opening sluice gate should not affect the stability of the dam at this time. The gate, however, should be repaired to ensure continued good operation. According to the design plans in Appendix C, the bridge over the spillway was designed for a 5 ton truck and the structure should be appropriately posted to prevent loss of both the bridge and spillway capacity.

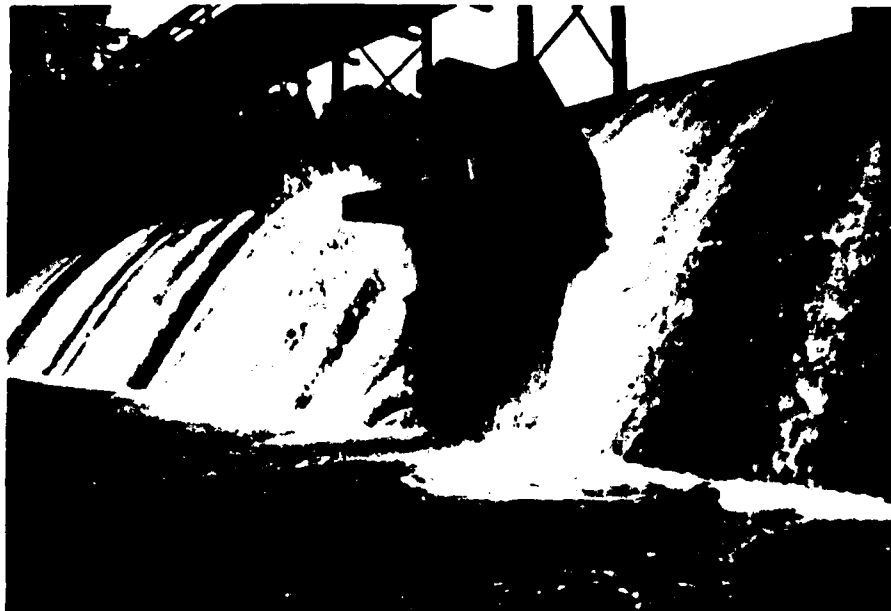
SPILLWAY FACE &
DRAIN OUTLET

2. The concrete surface of the ogee spillway was in good overall condition, but numerous spalls, 2 to 5 inches in depth, were detected on the lower portion of the spillway at construction joints.

1. The drain opening sluice gate on the left side of the ogee spillway section leaks considerably due to improper seating of the gate. Although the gate operation was not demonstrated during the field inspection, the reservoir was drained within the past year and the gate is assumed to be functional. Access to the gate control is by boat and during periods of heavy spillway discharge, operation of the gate will not be possible.
2. The bridge structure over the spillway appears to be in good condition. Judging from the relatively light structural members, the bridge has a low capacity but no weight limits were posted.

b. Overflow Spillway. Although the spalls in the ogee spillway face do not presently affect the stability of the structure, they should be repaired to prevent accelerated deterioration of the concrete. The open construction joint on the left side of the spillway apparently extends through the dam to the silt laden pool water. The stability analyses in Section 6 and Appendix E, however, suggest that the effect of the open joint upon stability is negligible. The debris accumulated on the spillway should be removed to maintain maximum available flow capacity.

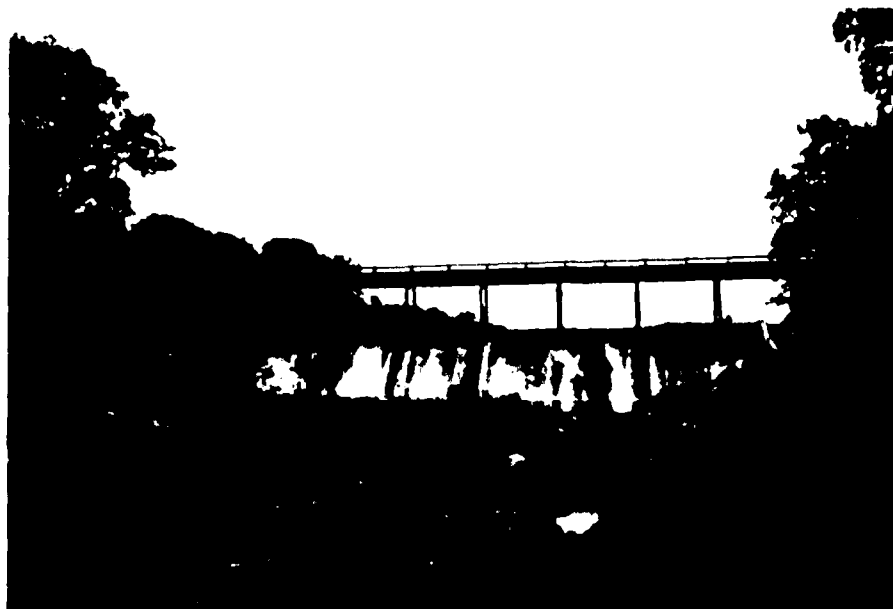
DOWNSTREAM VIEW

f. Downstream Channel. Discharge from the overflow spillway flows into a "stilling basin" formed in the natural stream channel by an accumulation of boulders 75 feet below the dam. The streambanks just below the dam are undercut and sloughing into the sides of the channel. The first mile of downstream reach consists of woodland, but the next 2 miles to the Susquehanna River are developed with more than 50 dwellings and summer cottages and the Maryland route 623 bridge over Broad Creek. In the event of a dam failure these dwellings would be affected and a hazard category of "high" appears appropriate.
